Interagency Commission on School Construction

Maintenance of Maryland's
Public School Buildings
Fiscal Year 2024
Annual Report

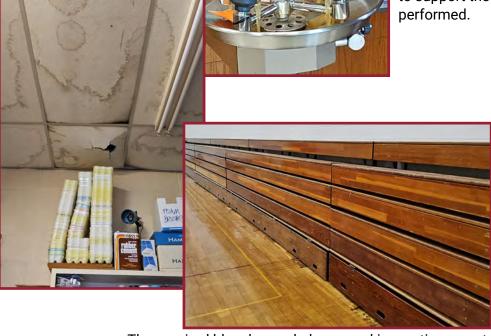
Multiple stained and damaged ceiling tiles were observed at two facilities. The ceilings were not included in the PM schedules. One facility received a Not Adequate rating for Ceilings.

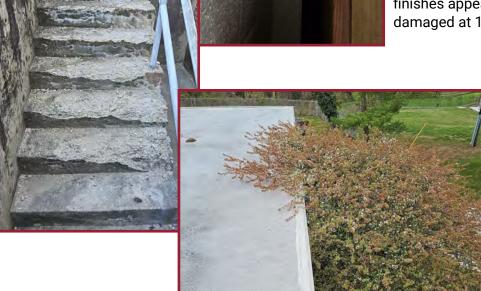
Trees were contacting building surfaces and/or growing over the roofs at 11 facilities. Some of the grounds were observed with notable erosion at three facilities.

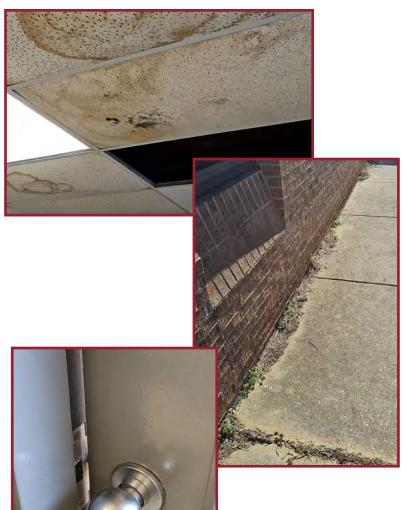
Relocatables and additional structures were not included in the PM schedules for the two applicable facilities. Potential hazards were noted at these structures at both facilities.

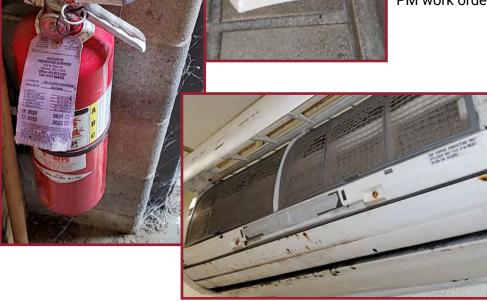
The required fire alarm inspection reports were not provided for any facility. Potential safety hazards were observed at two facilities. The fire and safety systems were not identified in the PM work order histories.

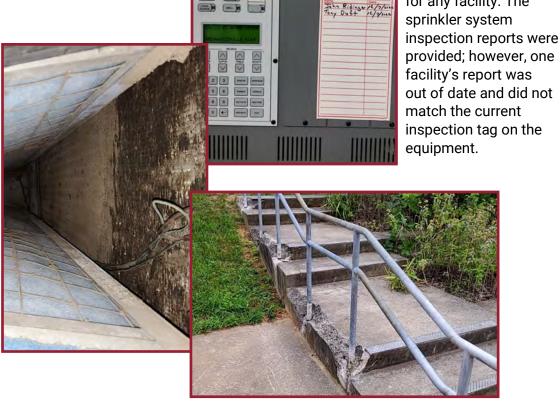
Cracked walkways and/or parking lots were observed at all four facilities. Damaged concrete stairs caused potential safety hazards at one facility. The roadways, parking lots, and walkways were not included in the PM schedules.

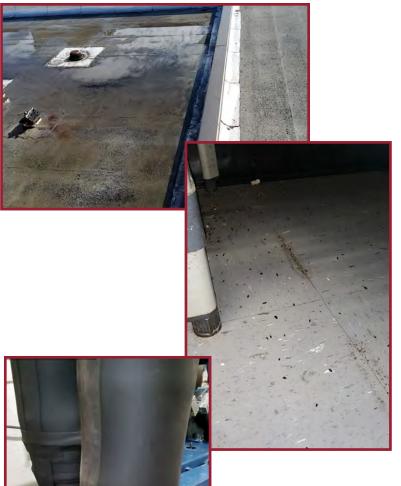
Blisters were observed on the roofs at two facilities and ponding water at all three facilities. One facility did not provide the required annual roof inspection report.

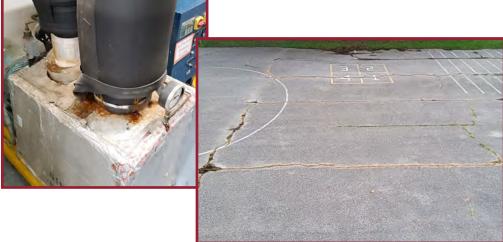
Potential safety hazards were identified in the play areas at two facilities. Vegetation was observed growing in play areas at two facilities.

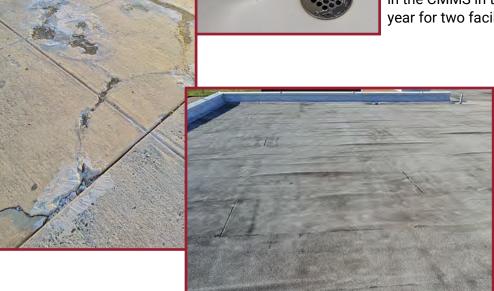
Damaged walkway surfaces which had the potential to be trip hazards were noted at two facilities. Vegetation was also observed growing from cracks in the walkways at both facilities. Roadways, parking lots, and walkways were not included in the PM schedules.

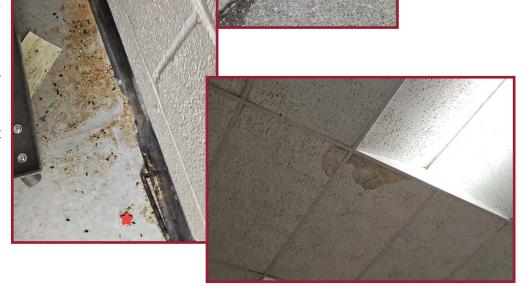
Unsafe storage practices were noted at two facilities. Evidence of pests was observed at two other facilities. Custodial and pest management activities were not included in the PM schedules.

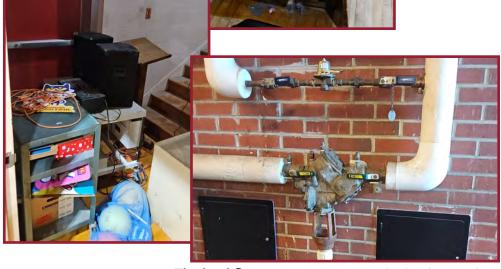
Unsafe storage practices were noted at all three facilities. Evidence of pests was observed in food storage areas at two facilities.

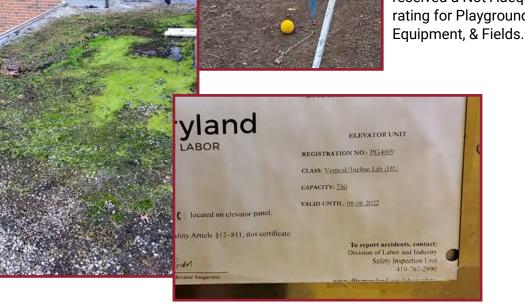
15 facilities received a Not Adequate rating for Roofs, Flashing, and Gravel Stops.

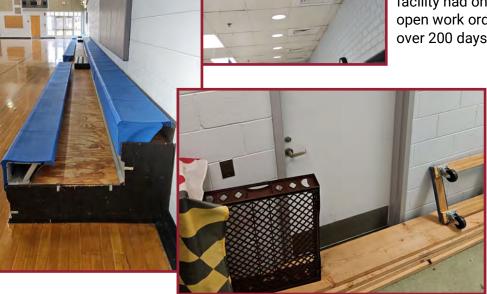
Unsafe storage practices and clutter were noted at one facility. Evidence of pests was observed at all three facilities, one of which was in a food storage area. Custodial and pest management activities were not included in the PM schedules.

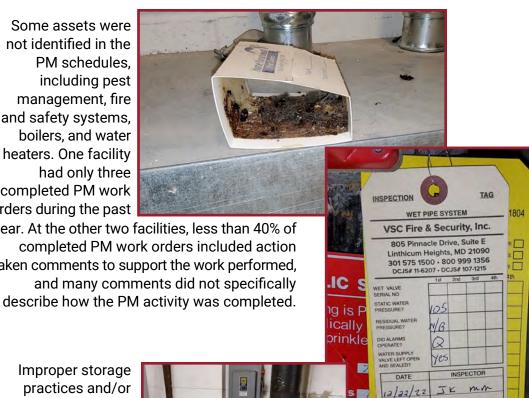
It did not appear deficiencies identified in the fire and safety inspection reports had follow-up corrective work orders input into the CMMS. The required fire suppression and sprinkler system inspection reports were not provided for one facility. The required monthly fire extinguisher inspections were not being completed in one facility. The fire extinguishers and required fire and safety system inspections were not included in the PM schedules.

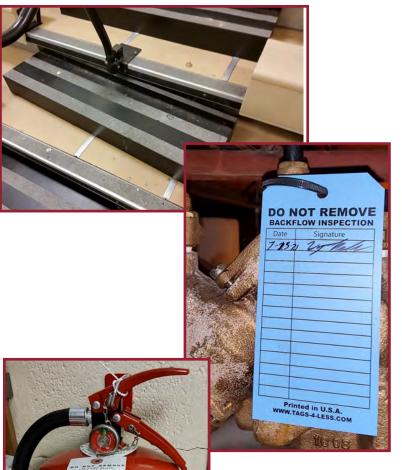
Backflow preventers were observed with failed inspections, leaks, and outdated inspection tags. Backflow preventers were not included in the PM schedules. Two facilities received a Not Adequate rating for Plumbing Fixtures and Equipment.

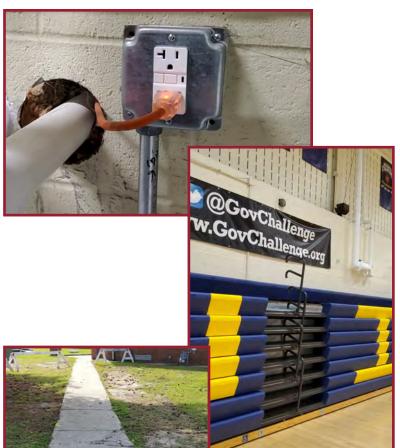
The requested bleacher inspection reports were not provided for the two applicable facilities. Two facilities received a Not Adequate rating for Playgrounds, Equipment, & Fields.

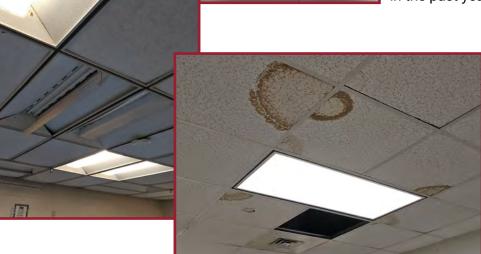
Multiple stained ceiling tiles were observed at all three facilities as well as ceilings that were damaged and/or missing tiles. The ceilings were not included in the PM schedules.
